Lutron RadioRA 2 main repeater – Upgrading repeaters affected by the 12.4 firmware update issue

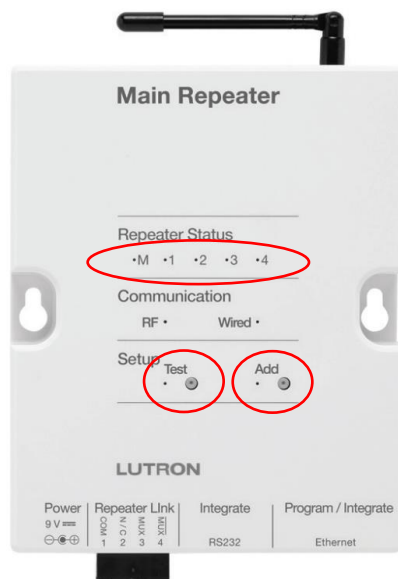
This process applies to RadioRA 2 main repeaters that are unable to be firmware upgraded and have a date code in the following list:

5C2	0D5
0D1	0D6
0D2	0D7
0D3	0D8
0D4

1. Power down the main repeater
2. While the main repeater is powered down, hold the “Test” and “Add” buttons on the front of the unit
3. While continuing to hold these buttons, power on the main repeater
4. Continue to hold the “Test” and “Add” buttons until the 5 status LEDs on the front of the repeater are flashing green
5. Open the RadioRA 2 software version 12.6
6. Upgrade the repeaters from the software following the normal procedure
