Fluorescent Dimming Ballast Installation Guide

- Installation Instructions
- Ballast and Control Wiring Diagrams
- Field Troubleshooting Information
- For Lutron Hi-lume®, Hi-lume Compact™, Tu-Wire™, and Eco-10™ Ballasts

LUTRON®

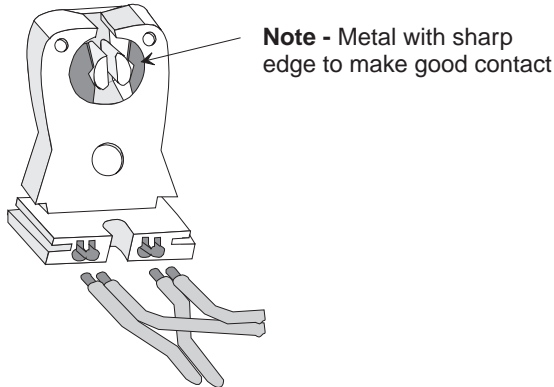
Rapid Start Sockets can accept 4 wires (2 for wires from the ballast and 2 for wires to another lamp).

When installing Lutron ballasts, socket type and wiring are important. Good filament contact and correct wiring are needed to produce flicker free dimming and to ensure long lamp life. For longest lamp life and best filament contact, use only **Rapid Start Knife Edge Sockets**.

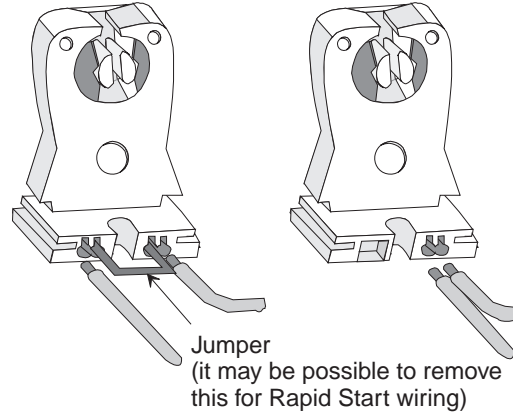
Instant Start Sockets can only accept 2 wires (1 wire from the ballast and 1 wire to another lamp) and must be replaced with Rapid Start sockets.

Using Lutron ballasts with Instant Start Sockets can damage the ballasts.

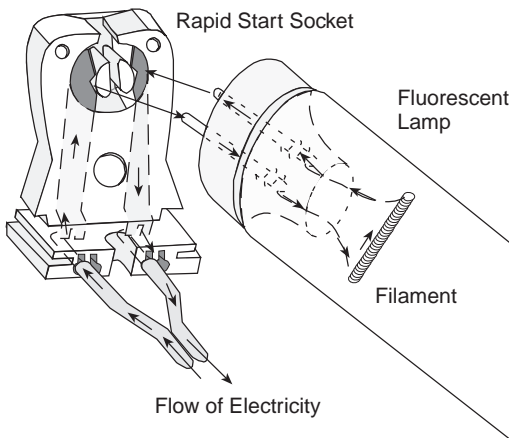
Why are sockets important?

Dimming ballasts must access both lamp pins to heat the lamp filaments—without heating the lamp ends will become black and fail prematurely (it may take a week or several months).

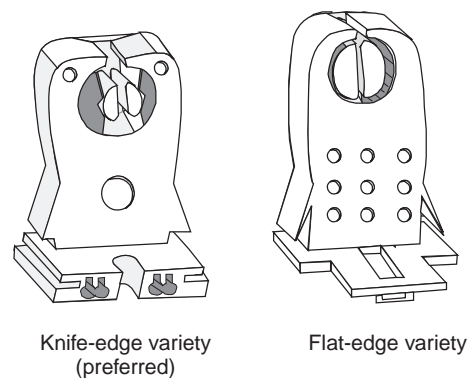
Why use a knife-edge socket?

A knife-edge socket makes superior contact with the lamp pin by contacting with a sharp edge rather than a flat surface. Dimming ballasts require good pin contact.

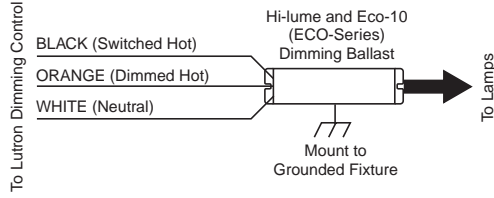
1 Hi-lume and Eco-10 (ECO-Series) Dimming Ballast

Note: Wire colors shown are for Lutron controls and ballasts only.*

Refer to page 4 for control to ballast wiring. Follow the proper wiring diagram for the type of control and ballast combination.

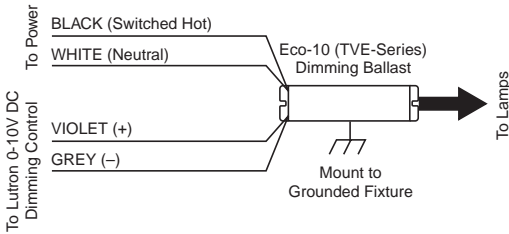
3 Eco-10 (TVE-Series) Dimming Ballast

* Control wire colors do not necessarily match ballast wire colors (e.g. control “dimmed hot” may be yellow and ballast “dimmed hot” may be orange).

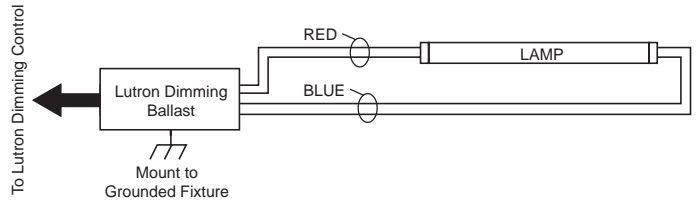
1 One Lamp

Note: Wire colors shown are for Lutron controls and ballasts only.

Refer to page 4 for ballast to lamp wiring. Ensure that lighting fixtures are wired as per the proper diagram.

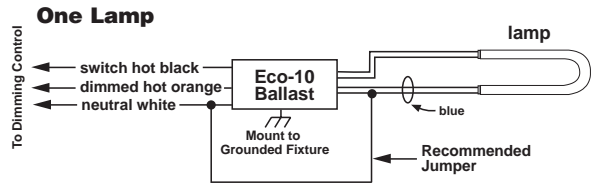
Wiring Eco-10 Ballasts with 1 5/8" T8 U-Bent Lamps

Wiring of one- and two-lamp Eco-10 (ECO-Series) ballasts should be modified to aid striking when the ballasts are used with 31W, 1 5/8" U-bent lamps only. A jumper wire should be connected from either blue wire to neutral. Jumper does not affect UL listing. This jumper is not required for three-lamp ballasts.

The blue wire to neutral jumper applies **only** to the following four ballast models:

- ECO-T832-120-1
- ECO-T832-120-2
- ECO-T832-277-1
- ECO-T832-277-2

Jumper connections should not be made on any ballast model other than those listed.

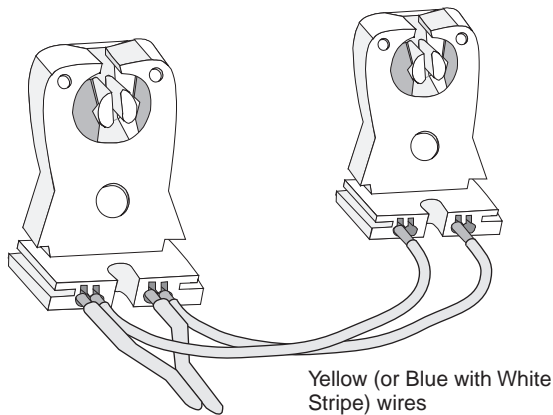
Correct - wired in parallel.

Check for proper socket wiring

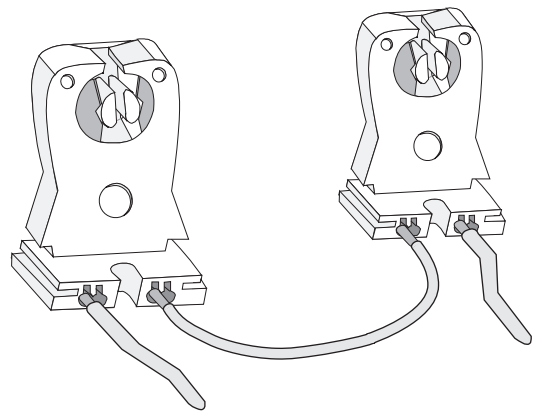
Wrong - wired in series.

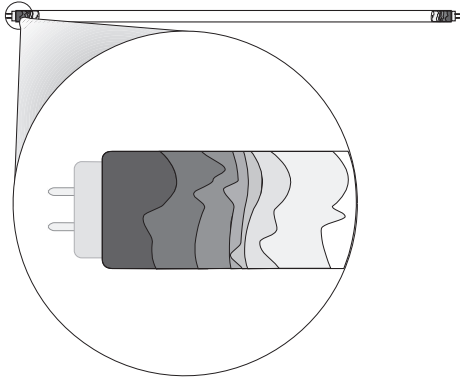
Lamp that was **NOT** seasoned for 100 hours.

New fluorescent lamps have impurities in them which lamp manufacturer cannot eliminate completely. Lamps must be operated at full intensity for 100 hours **before dimming** to neutralize the harmful effects of these impurities. Without the 100 hours at full intensity, the impurities may cause the lamp to fail within a week (or failure may take months depending on usage and the amount of impurities).

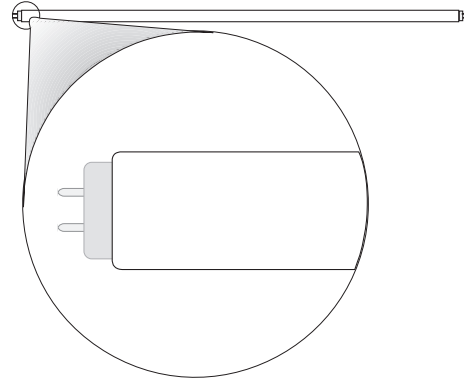
Lamp that **WAS** seasoned for 100 hours.
